Station Paper No. 55

December 1960

³
**A STUDY OF
EARLY GULLY-CONTROL STRUCTURES
in the Colorado Front Range**

by
Burchard H. Heede
Research Forester

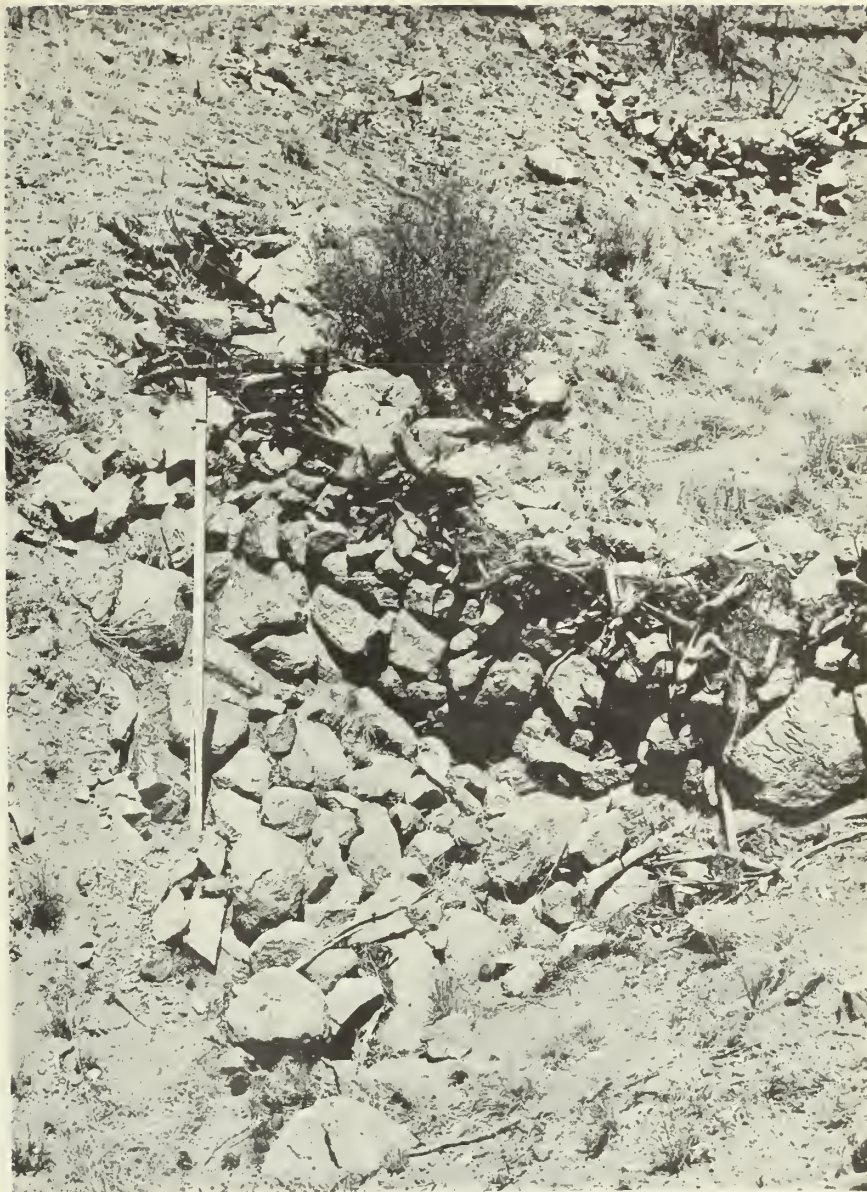
Figure 18. --In the 1930's Reuter gully was treated by the U. S. Civilian Conservation Corps. Loose-rock check dams were installed and willow root cuttings planted in the channel. Little evidence of the plantings can be detected now. The dams arch and possess wing walls that are placed upstream from the structures. Limbs from tree pruning were imbedded in the dams. The ends of the cuttings, projecting through the dam wall, point upwards to prevent the slipping of the upper rock layer. These cuttings caused the breakdown of the rim wall when the wood rotted. Consequently, otherwise successful structures lost part of their sediment deposits.

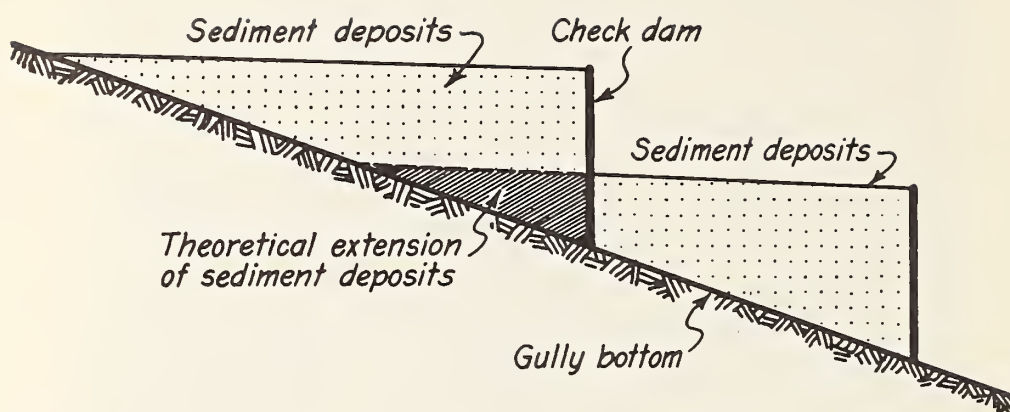
Figure 19. --The spacing of check dams was based on the head-to-toe rule. However, fewer dams would have been needed if they had been placed at the expected upstream toe of the deposits.

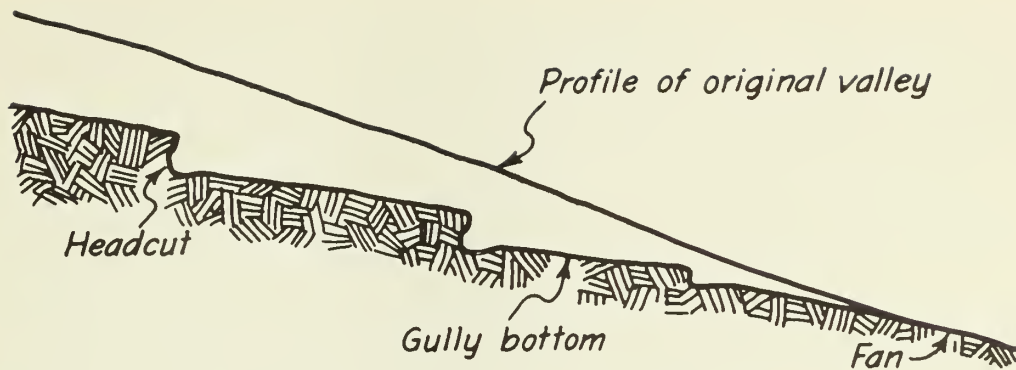
The upper segment of the Nursery gully system indicates that a discontinuous gully system may become a continuous one (fig. 20). Small headcuts in the upper reach of the lower segment show that this part had its origin in a series of individual gullies. No evidence could be found that showed the development of the lower channel reach. It is not known whether the characteristics of gully formation are different for a discontinuous and a continuous system. This knowledge would be of great importance to gully erosion control.

Figure 20.--This is a longitudinal profile of the upper segment of the Nursery gully system at the Manitou Experimental Forest. It consists of several individual discontinuous gullies. This system is characterized by (1) pronounced headcuts in the valley floor that mark the beginnings of individual gullies; (2) rapidly decreasing channel depth downstream; and (3) fans of sediment at the gully mouths. The slope of a discontinuous gully is always less than the original valley slope. Accelerated erosion advances and the distance between the gullies decreases until one continuous channel is established. In the drainage segment illustrated, the headcuts of the individual gullies are still visible in the channel, and channel depth is still decreasing rapidly. The fans below the individual gullies are obliterated by gully fusion, but a larger fan developed at the mouth of this system.

The segment demonstrated by figure 20 has a maximum channel depth of 4 feet. It is proposed to use loose rock as the construction material. The headcuts will be filled with loose rocks and sloped $1\frac{1}{2}:1$ into the channel. At the toe of the fill a check dam is needed to stabilize the fill and to dissipate the energy of the flow. The check dam should possess a discharge capacity at least equal to the estimated peak flow from the design storm.

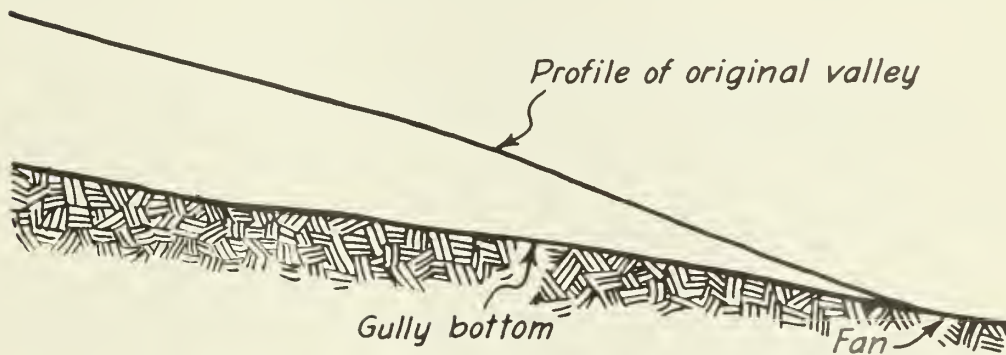
Figure 21.--This profile shows the lower segment of the Nursery gully system. It is a continuous gully. The channel slope approaches the gradient of the original valley floor. The gully starts in the upper drainage without a pronounced headcut. Rills and shoestring gullies mark its beginning. It deepens rapidly downstream to a point above the gully mouth. Here, the longitudinal profile becomes concave and channel depth diminishes until the gradients of the original valley floor and the channel bottom intersect at gully mouth. Below the gully mouth, a fan of sediment is formed on the main flood plain.

The lowest segment of the continuous Nursery gully illustrates reoccurrence of gully erosion caused by the failure of the dam at gully mouth. This dam was weaker than those installed upstream (see fig. 3). As a result of the structural failure, a new channel gradient was established that lowered the gully base level for 650 feet upstream. The headcut undermined four check dams and is still active (see fig. 21).

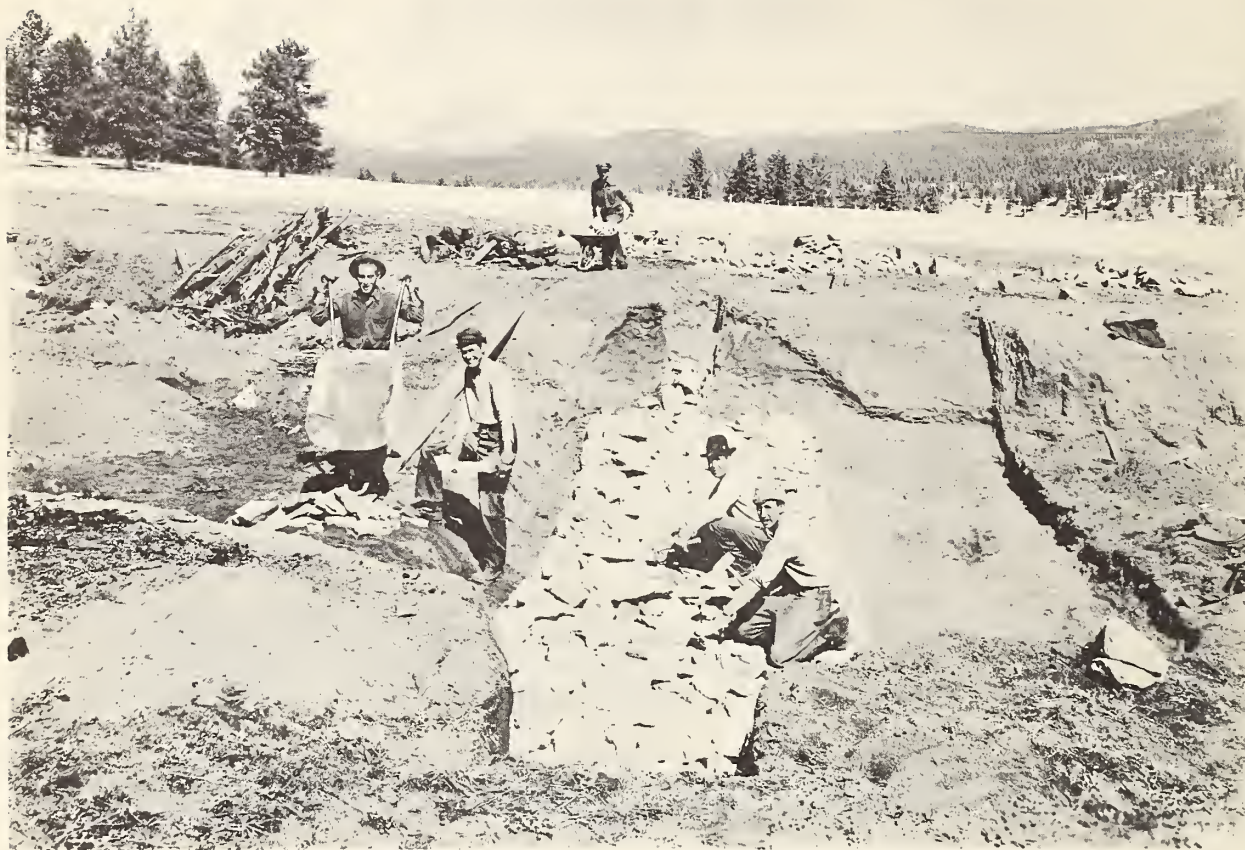
Figure 22. --Loose rock-mesh wire dam under construction by the U. S. Civilian Conservation Corps in 1939. A check dam should be keyed into the solid gully banks and into the channel bottom as shown. On the average, bank slots 2 feet deep and a core of 1-foot depth in the channel bottom were sufficient to anchor the structure. Bank keys should extend above the dam crest and into the channel to protect the gully banks from the erosive impact of the flood crest.

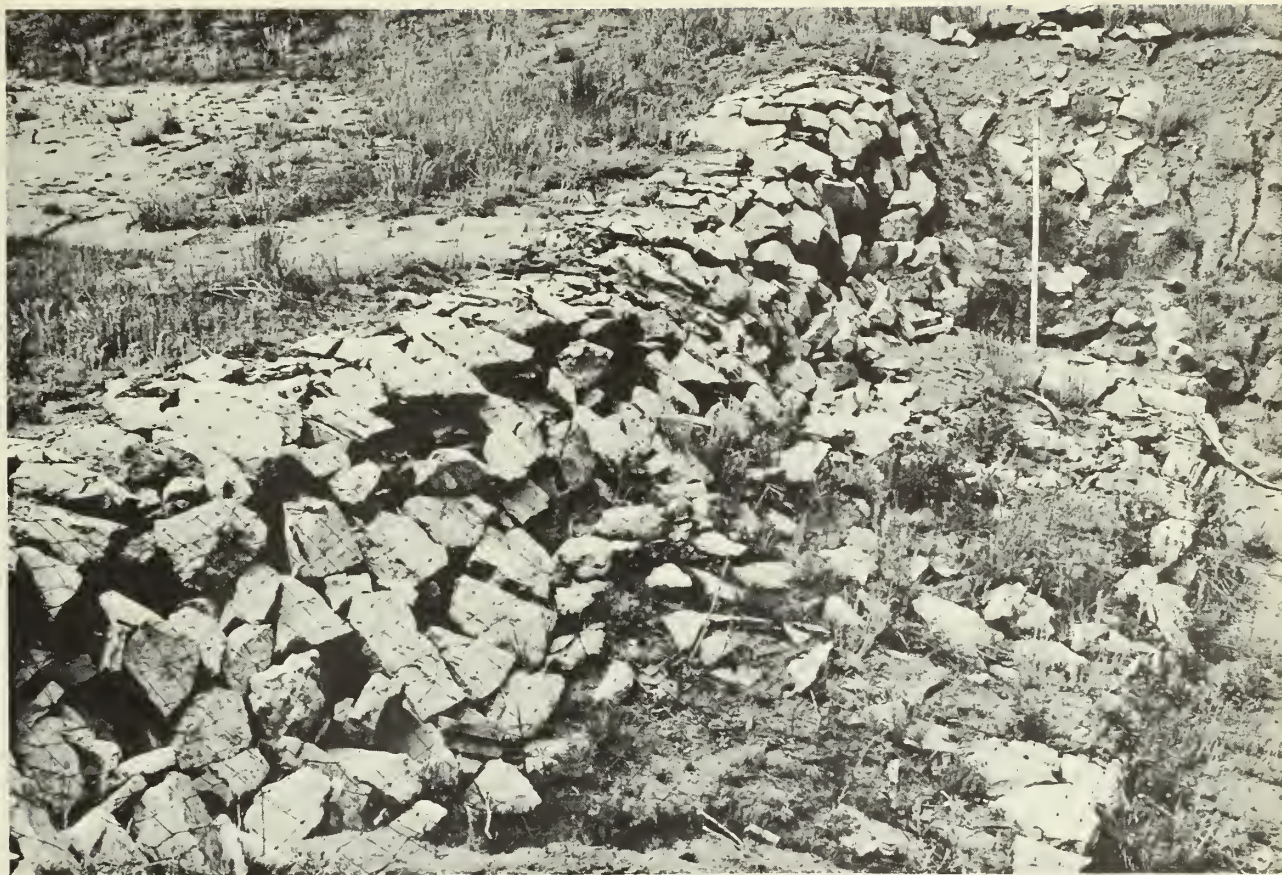
Figure 23.--This is the same check dam 20 years later (see fig. 22). It has a height of 6.5 feet and an apron length of 6.5 feet. The apron was effective. Since the falling water endangers the channel bottom below a dam, an apron is necessary to dissipate the energy of the water when it reaches the bottom. Insufficient quality and length of an apron may lead to undermining of the installation. Bank erosion below the check dam has started because bank protection was inadequate.

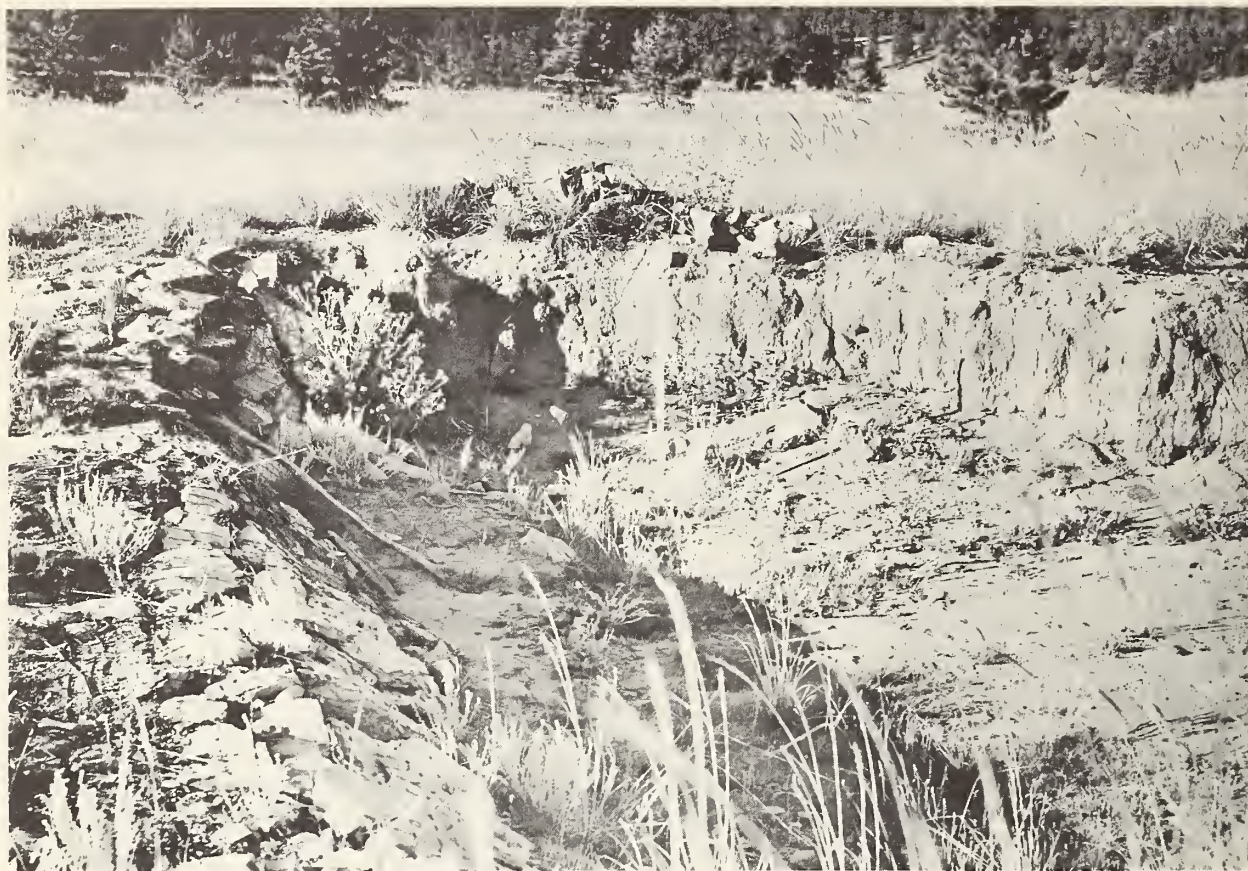
Figure 24.--Adequate bank shielding below a check dam is essential to prevent destruction of the dam keys. When the waterfall strikes the channel floor, eddies develop that wash against the banks. If not controlled, the eddies may wash out the banks and undermine the structural keys as seen above. The loss of the anchor will result in obliteration of the dam. When the effective length of a dam is greater than the width of the gully bottom, then part of the waterfall will strike directly on the bank. Bank shielding below such dams is particularly necessary. (Height of rod = 5.5 feet.)

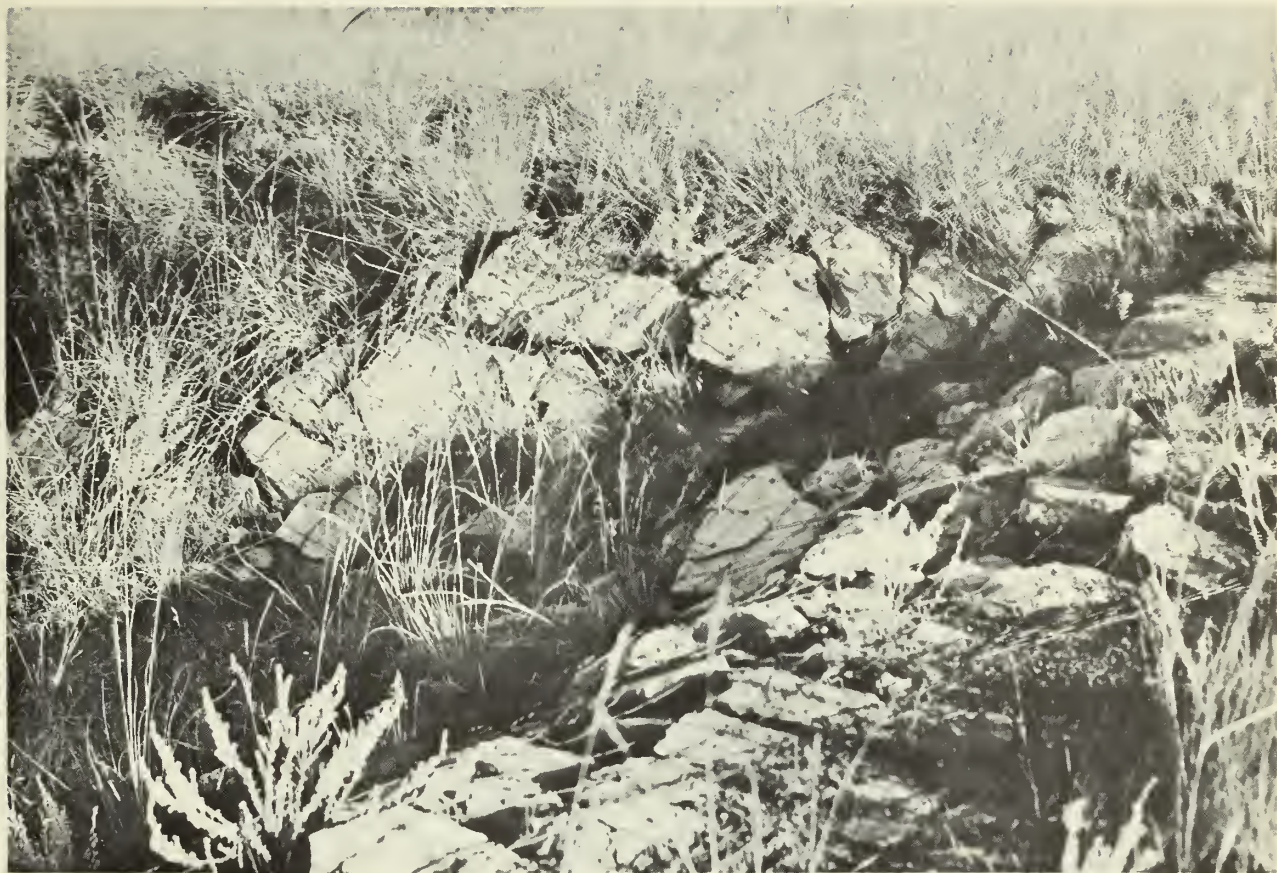
Figure 25.--Successful bank protection below a check dam. The bank shield consists of layers of loose rocks held to the bank by galvanized wire mesh.

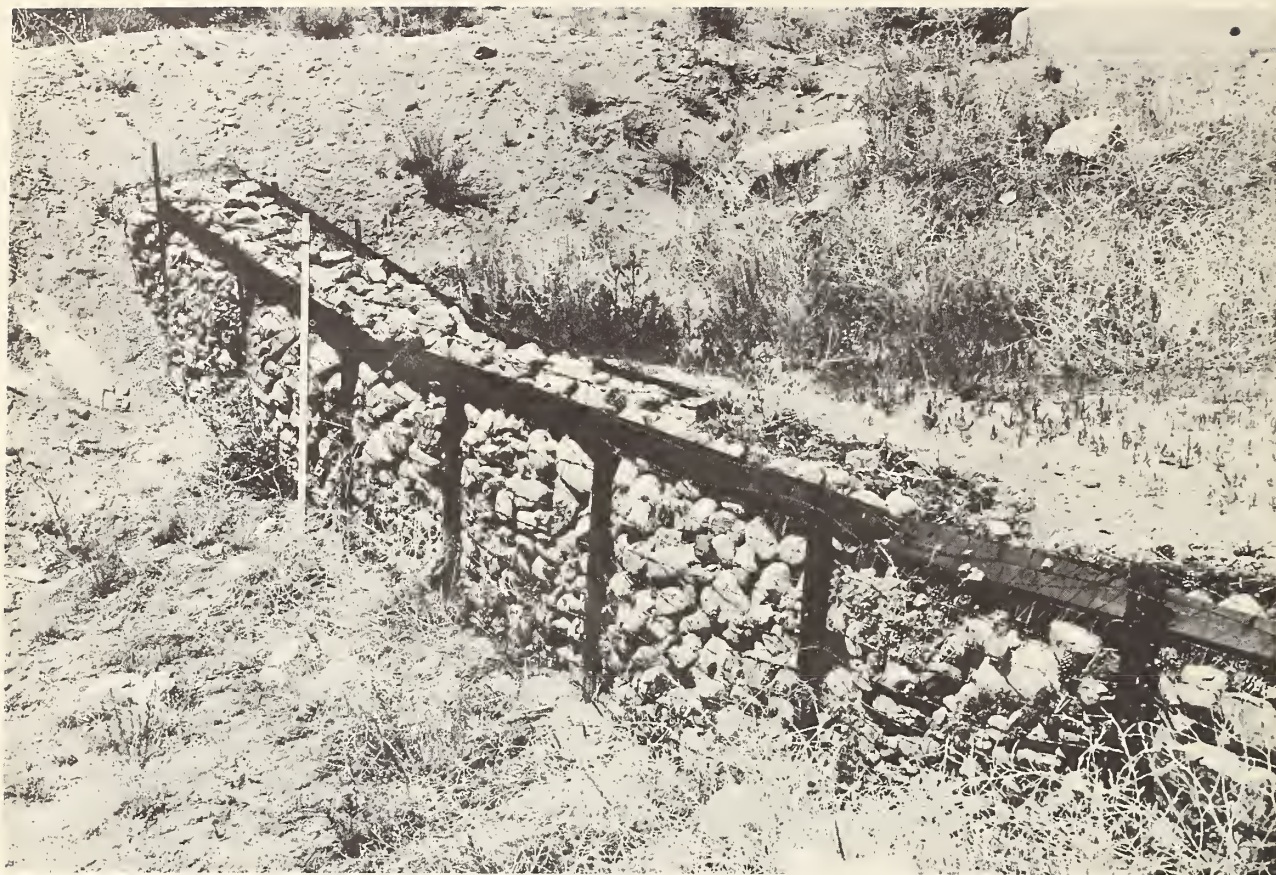
Most successful materials for check dams were steel, masonry, and loose rocks reinforced by galvanized woven wire. Gabion-type structures proved to be highly successful (fig. 26).

Figure 26.--A highly successful gabion-type check dam built from steel rods, galvanized woven wire, and cobblestones. Structure installed by Colorado State Highway Department in connection with the relocation of U. S. Highway 24 in 1938. (Height of survey rod = 5.5 feet.)

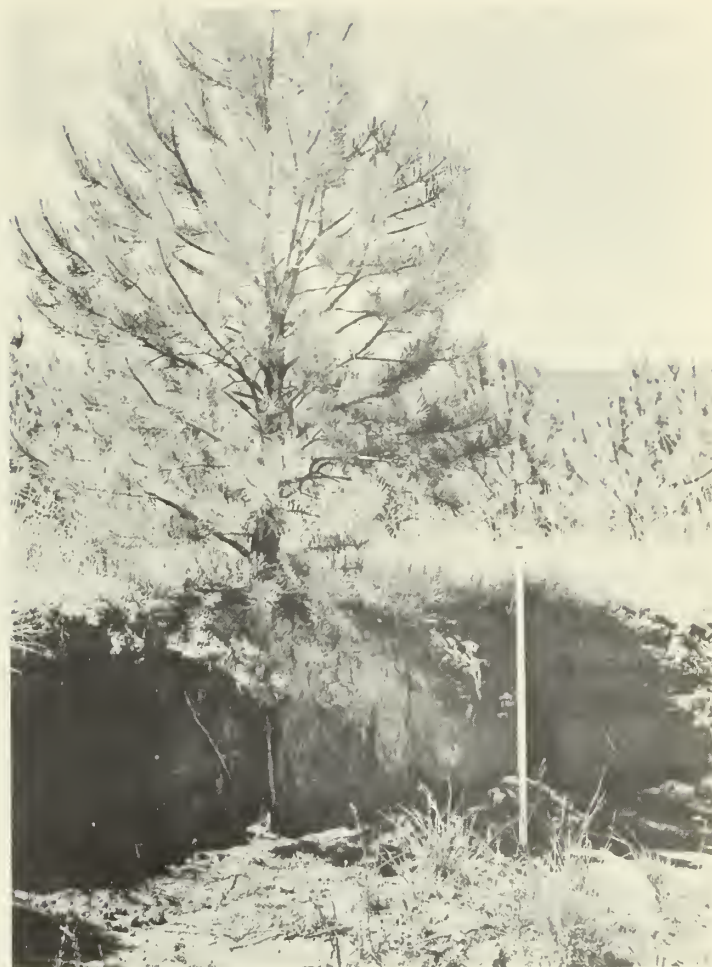
Figure 27.--

Flows with shallow
depth undermine
gully banks.
Nursery gully,
Manitou Experi-
mental Forest.
(Height of rod =
5.5 feet.)
